Archaeological and Biological Examination of the Brick Wreck (8MO1881) off Vaca Key, Monroe County, Florida

Roger C. Smith, Jeffrey T. Moates, Debra G. Shefi,
and Brian J. Adams, with Contributions by Brenda S. Altmeier,
Lee A. Newsom, and Colleen L. Reese

A Report Submitted to
the Florida Keys National Marine Sanctuary
in Fulfillment of a NOAA Maritime Heritage Program Mini-grant
October 2006

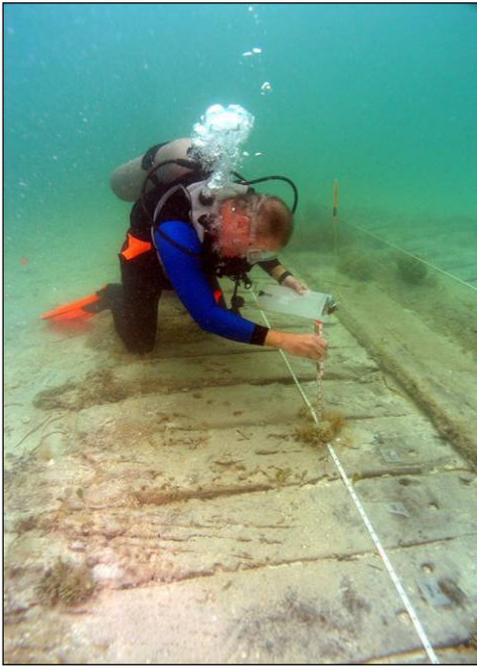
Figure 7. Measuring room-and-space

Archaeologists laid a baseline along the centerline of the vessel remains as the primary tool for documenting structural elements and orienting archaeological divers to certain areas of the shipwreck site. The baseline, laid with 3/8 in. nylon line, measured 78 ft. in length and was tied to iron rebar stakes placed directly forward of the bow and aft of the stern. The stakes established two datums: 'A' in the bow and 'B' in the stern. A 90-ft. reel tape was secured to it with zip-ties. The zero point of the baseline tape was established at the forward most point of the bow remains. Measurements using 90° offsets were taken from 5-ft. intervals along the baseline to reconstruct the outermost edges of the site in plan view. Archaeologists recorded room-and-space measurements of the vessel's framing timbers for their exact location in relation to the baseline. Exposed remains of the site were drawn by hand on mylar and recorded in relation to each other. An overall site plan depicting the extent of the surviving timbers, ballast, and large iron objects

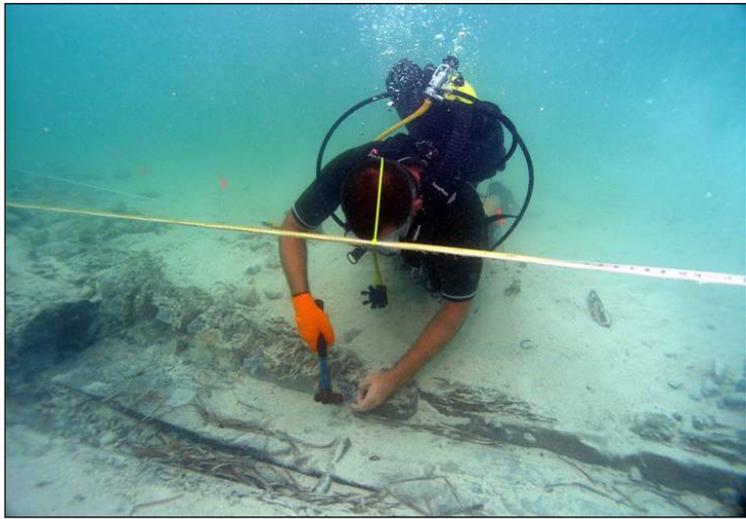
Figure 12. Tagging starboard Frame 66 in the stern; note visible portion of keel obscured by sand

The keel is exposed only in the stern, aft of where the keelson terminates (Figure 11). Estimated overall length of the keel is 69 ½ feet. Molded height of the keel could not be determined. Sided thickness is 12 inches. Concreted remnants of iron drift bolts were noted along the forward portion of the vessel remains. Treenails were observed fastening the garboard strakes in the stern, on both starboard and port sides. A wood sample of the keel was retrieved just forward of the sternpost assembly. Below the after terminus of the keelson, the keel was found to be notched to accept the aftermost half frame (see Figures 13 and 14). Dimensions of the notch were not determined.

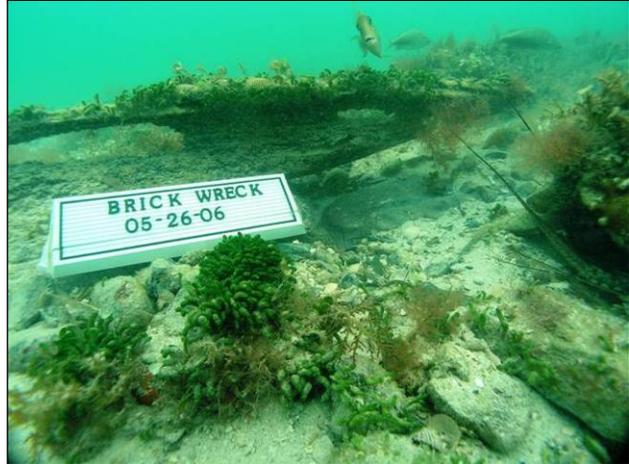
Figure 13. Location of scarph; note eroded upper remains of keelson

The keelson is a primary feature of the hull remains. Although badly eroded and worm-eaten, the keelson runs 62 feet in length from the portion in the bow that sits above the stem to its after terminus. Sided thickness is 12 inches, same as the keel, and the approximate molded height is 14 inches. The keelson was fastened to the frames and keel with iron drift bolts, as evidenced by the iron-oxide impregnated upper remains of the keelson. The keelson is scarphed together (with a 2 feet 9 inch scarph), situated 24 feet 8 inches aft its forward end (Figure 12). An iron drift bolt was observed just forward of the scarph, but none in the scarph itself. The eroded and worm-eaten remains of what appears to be a longitudinal bulkhead on the after section of the keelson begins at 44 feet 7 inches and ends at 60 feet 9 inches along the baseline for a total length of 16 feet 2 inches.

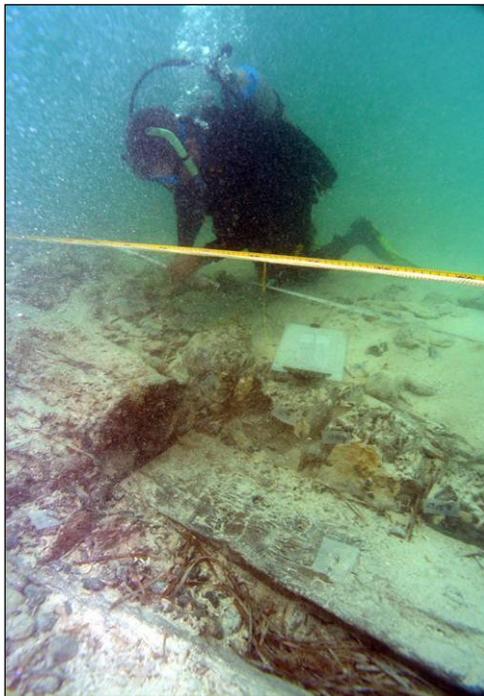
Figure 14. Recording room-and-space near after terminus of keelson

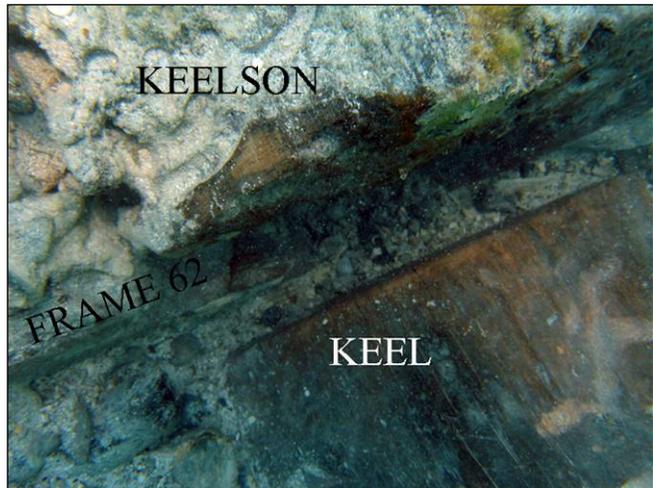
Figure 15. After terminus of keelson and notch in keel

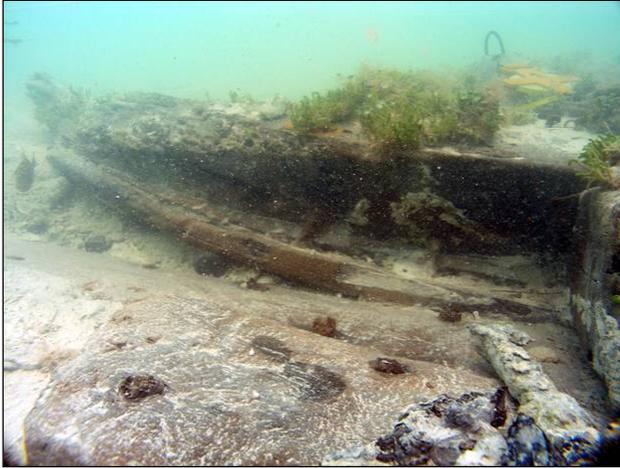
Figure 16. Port elevation of stem and garboard; hull planking in foreground

The stem is 6 feet 7 inches in length. Although the vertically rising forward portion of the stem has eroded away, the intact portion abuts the first full frame or floor timber (designated Frame 1). The stem most likely is scarphed to the keel aft of the canted half-frames in the bow and below this abutment. Molded height of the stem to the top of the garboard rabbet is 9 ½ inches. Given the 2 ½ inches thickness of the garboard strake, this would make the molded height at least 12 inches. Sided thickness of the stem is 18 inches. Concreted remains of an iron fastener were noted just forward of where the keelson begins.

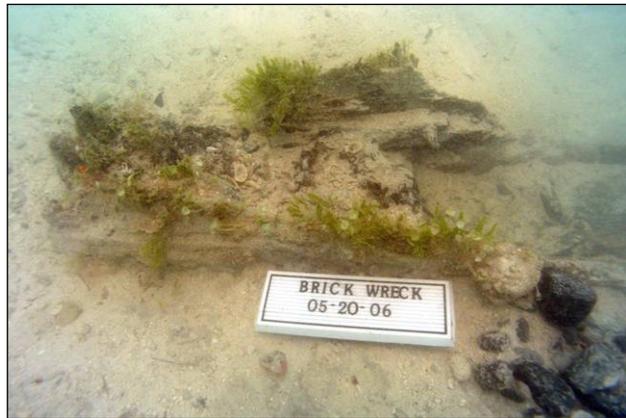
Figure 17. Stern assembly (from right to left): inner sternpost, sternpost, and iron strapping or lower gudgeon

Remains of a sternpost and inner sternpost comprise a discreet assembly at the after end of the hull. Where these timbers were stepped into the keel, they are 8 inches sided thickness and 14 inches molded height. There appears to be evidence of an iron strap, or lower gudgeon, wrapped around the after end of the assembly. No evidence of deadwood was observed.

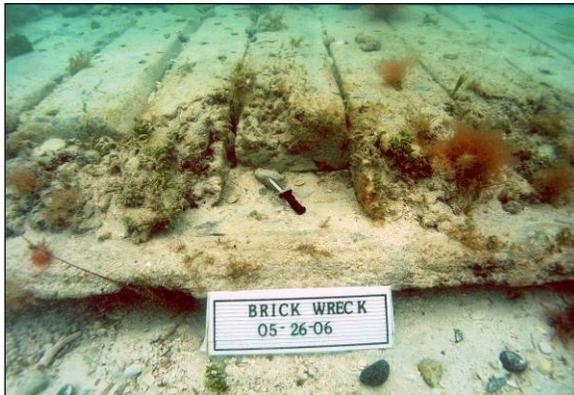
Figure 18. Starboard floors and half-frames; wronghead in center is starboard Frame 19

The vessel's lower hull is heavily framed with floors, half-frames, and the eroded remains of first futtocks. On the starboard side, there are three canted bow frames, 60 framing timbers (floors and half-frames), and six half-frames in the stern. On the port side, only two cant frames in the bow and three half-frames in the stern are extant. Worm-eaten remains of chocks are present between cant frames 2 and 3 on each side of the stem. Average sided dimension of the frames, taken from room-and-space measurements, was determined to be 10 ½ inches throughout. Molded height of frames averaged 9 inches.

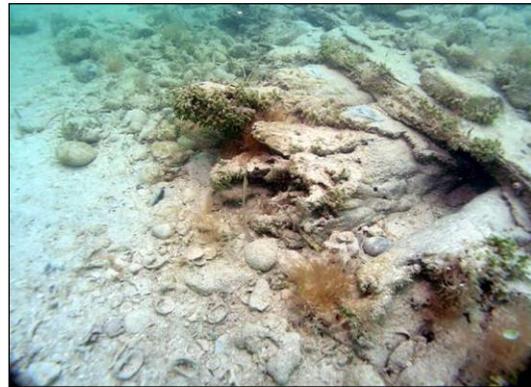
Figure 19. Starboard frames 47, 48, and 49 looking aft; note large space aft of frame 47 (at right)

On average, space between floors and half frames throughout the extent of the hull measured 1 inch. However, archaeologists noted larger than average spaces between discernable frame pairs starting aft of Frame 47 on both sides of the hull. Room-and-space data reveal that in the after portion of the hull, starting at Frame 47, the space between frame pairs is 1 ¾ inches wide. Forward of this point in the hull the space between floors and half frames, where distinct frame pairs are not discernible, averages three-quarters of an inch.

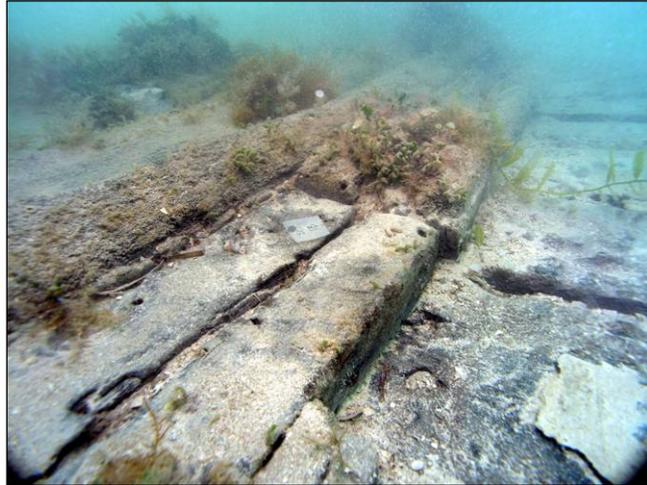
Figure 20. Ceiling near bow looking forward; note eroded remains of keelson

Only a few strakes of ceiling planking remain on the lower hull. Ceiling planks are 3 inches in thickness and vary in width from 8 ½ to 12 inches. However, the forward-most ceiling planking adjacent to the keelson measure 5 inches thick and terminated at Frame 5. The reason why these forward planks are heavier than the rest is unclear, but they may have been intended to reinforce the portion of the hull where the stem joined the keel.

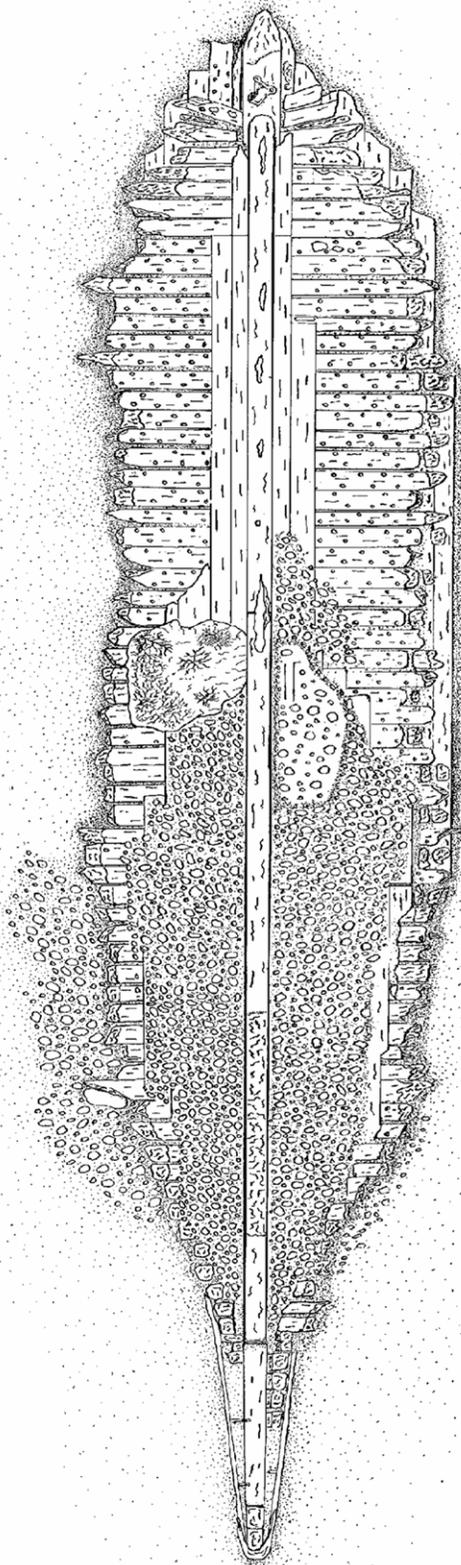
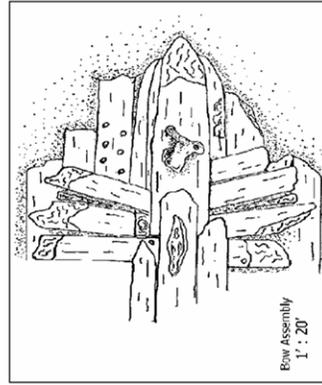
Bow Assembly
1" : 20'

Brick Wreck
SMO1881
Florida Bureau of Archaeological Research
Site Plan by Brian Adams
May 2006

Framing in the bow consists of three cant frames on the starboard side and two cant frames on the port side. In general, the canted frames exhibited a 9 ½ inches sided dimension and molded height of 8 ½ inches. Two chocks were inserted between the second and third cant frame on each side of the stem. At their widest point, the eroded chocks were 3 ½ inches and tapered inboard to a point. The sided dimension of port cant frame 3 was tapered to 5 inches where it meets the stem. It was noted that these cant frames were inserted so that they abut each side of the stem (see site plan for bow assembly).

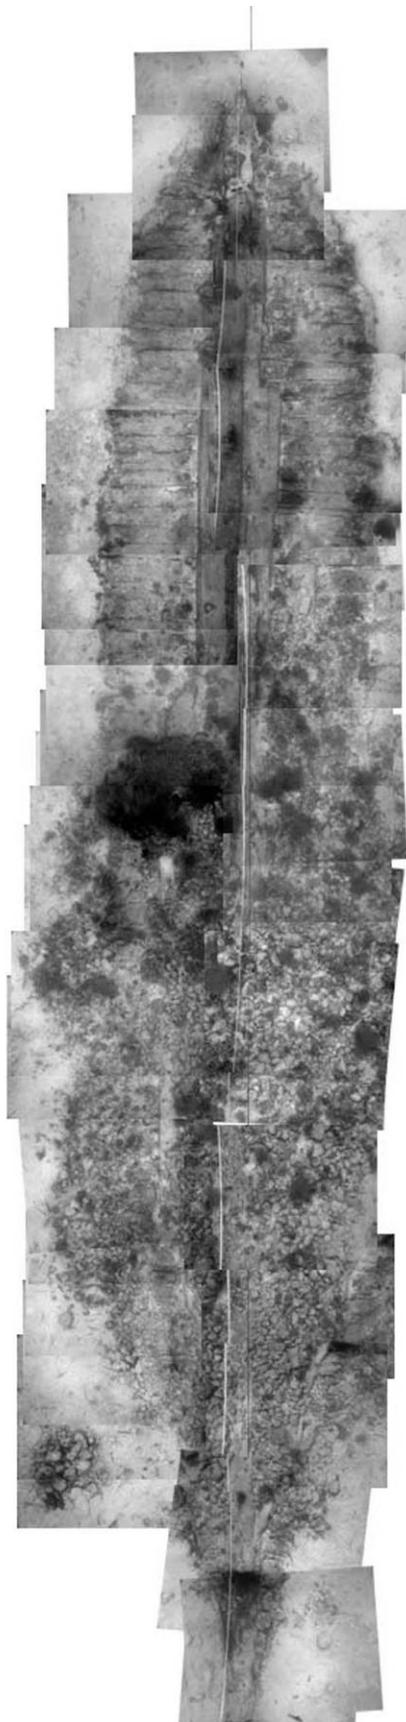
Brick Wreck
SMO1881
Florida Bureau of Archaeological Research
Photomosaic by Brenda Altrmeier
May 2006

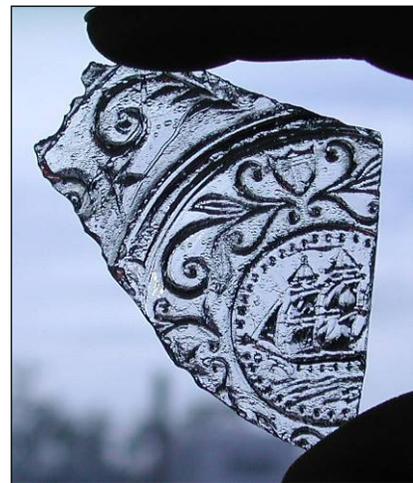
Figure 22. Pressed cup plate fragment

The delicately designed cup plate fragment is pressed glass and consists of a ship motif with decoration encircling the center of the plate. The recovered piece is part of the inner portion of the plate. This particular fragment is part of a classification of historical American Cup Plates succinctly labeled as the Ship Group by authors Lee and Rose, who assembled an extensive catalog of these glass plates. According to their research, this cup plate was pressed

21. Shell-edged pearlware.....	23
22. Pressed cup plate fragment	24

The cup plate pattern in question, with a three-masted ship encircled by scallops and stars, has been referred to as the *Cadmus* design, after the ship that brought the Marquis de Lafayette to the United States in 1824, but this assertion is questionable, since *Cadmus* employed steam and sails.²⁷ Alternately, the frigate *Constitution* has been suggested.²⁸ The ship probably just represented American trade and maritime commerce. More importantly, the manufacture date of the cup plate provides a *terminus post quem* (1840) for the sinking of the Brick Wreck.

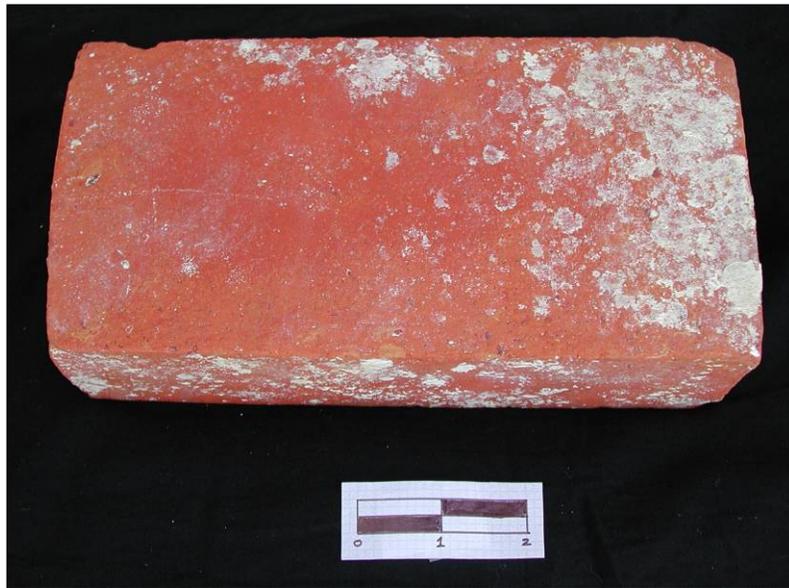
Figure 24. Example of recovered brick

Ten whole bricks and fragments were observed by archaeologists on the site. Researchers recovered two whole bricks. All of the bricks appear to be uniform in size, sharp-sided, and are a distinctive red-orange in color. The brick pictured below measures $8\frac{1}{8}$ inches in length by $4\frac{1}{16}$ inches in width by $2\frac{3}{8}$ inches thick (approximately 77 cubic inches). It exhibits little surface erosion, a testament to its durability, although this condition most likely is the result of the object only recently being uncovered. Crushed brick, sand, and a few small granite pebbles were included with the clay for tempering during manufacture and are visible on the brick surfaces. It is unclear whether these bricks were machine-made or molded. Machine manufacturing of bricks began in the 1860s. It is often hard to identify the manufacturing technique used even when examining a brick's color, measurements, and hardness.

Brick studies conducted by William Lazarus and Stanley South relate brick size with some accuracy to ethnic and regional identifiers.³⁰ It goes without saying that a large sample size is always best when comparing archaeological data. Nonetheless, the information obtained from comparison using a small sample, while never definitive, still can provide value for further research. Using South's Index Number method,³¹ which differentiates between brick sizes and changes in manufacturing standards, the bricks recovered during the Brick Wreck investigation have an average Index Value of 117. In comparison, this number correlates with bricks identified by Lazarus and South as being manufactured in various sites throughout the Eastern U.S. in the 19th century.³² Thus, the contribution here is that, with some degree of certainty, these bricks were manufactured in America in the 19th century.

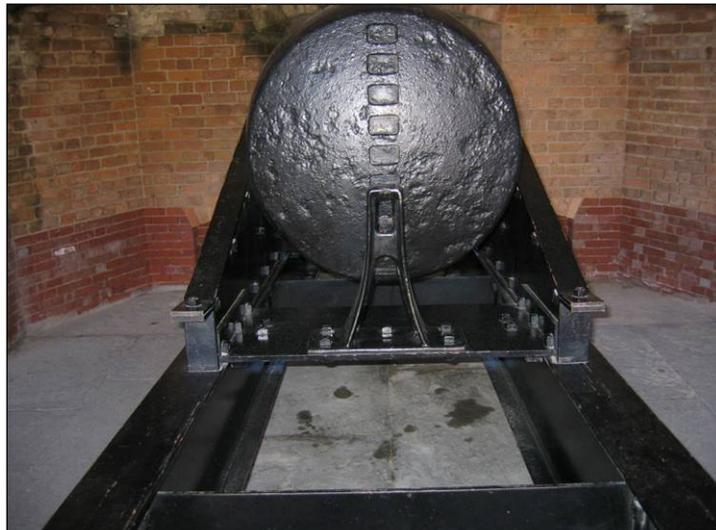
Figure 25. Rodman gun casemate at Fort Taylor, showing earlier and later bricks used in construction (Courtesy of Jim Miller)

Local lore about the Brick Wreck associates the vessel with the importation of bricks for the construction of Forts Taylor or Jefferson, which occurred during the middle of the 19th century. Today at Fort Taylor, one can see that there are at least two different types of bricks used in the construction of the fort. Early on, bricks were imported from northern brickmakers and used for masonry in the first tier only, stopping at the base of the gun embrasures. They have a distinctive red color, fine grain, sharp edges, and a uniform size. The bricks are so well made that the mortar joints are very narrow, closer to $\frac{1}{8}$ than $\frac{1}{4}$ inches.³³ Due to difficulties in obtaining a sufficient quantity of materials, bricks later were imported from southern sources, mainly Mobile and Pensacola. A photograph of the casemate at the restored Rodman gun at Fort Taylor shows the difference between the earlier and later bricks.

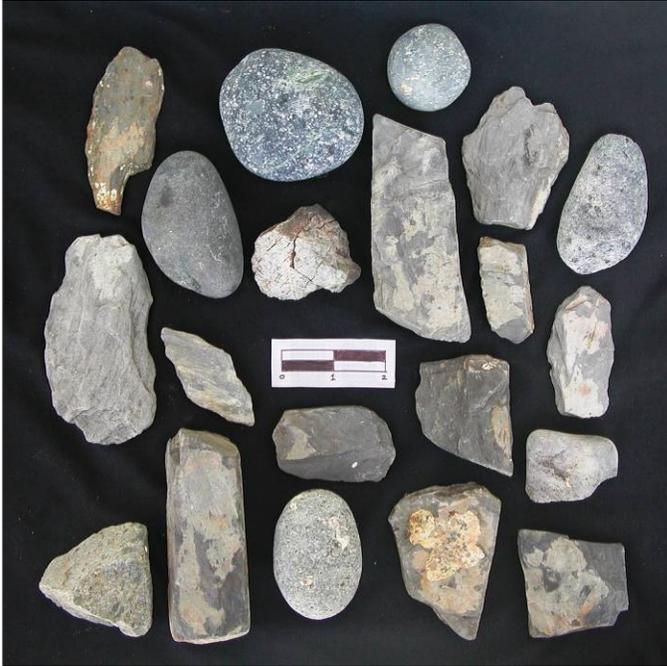
Figure 26. Example of ballast; round river rock and pieces of slate.

Ballast from the Brick Wreck included round river rock, consisting mostly of small pea ballast and pieces of slate. Most of the ballast observed on site was not bigger than an average adult's fist. However, a few larger rocks were present but scarce throughout the noticeably flattened and relatively sparse ballast pile. Researchers twenty samples for analysis and possible identification. BAR researchers transported the ballast samples to the Florida Geological Survey offices located at the Florida State University in Tallahassee. Harley Means and Dr. Thomas Scott of the Florida Geological Survey suggested that the samples, river rock and slate, likely originated from North

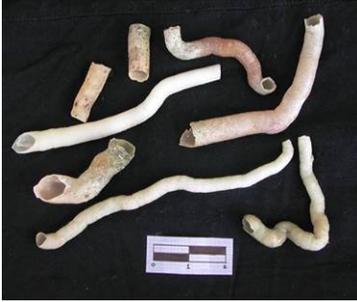
Twelve calcareous tubes from *teredo navalis*. Shipworm activity collected from areas of the port-stern ranging from $\frac{1}{4}$ inch O.D. to $\frac{11}{16}$ inch O.D. and in length from $1\frac{1}{2}$ inches to 8 inches. These samples were recovered from the ballast pile in an area where ships timbers were completely absent and are remnants of shipworm activity probably post-deposition when the lower hull was exposed.

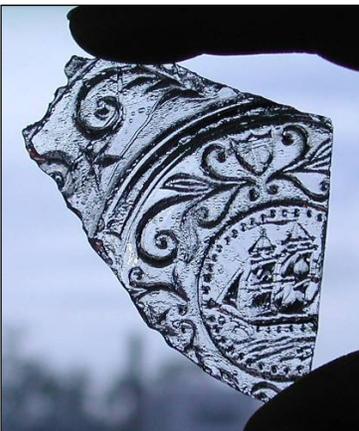
Pressed glass cup plate fragment. The image consists of a ship motif with decoration encircling the center of the plate, simple foliage, shields, and stars.
